Inspection Report

Property Address:
123 Main Street
Somewhere GA 55555

Keystone Inspections, LLC

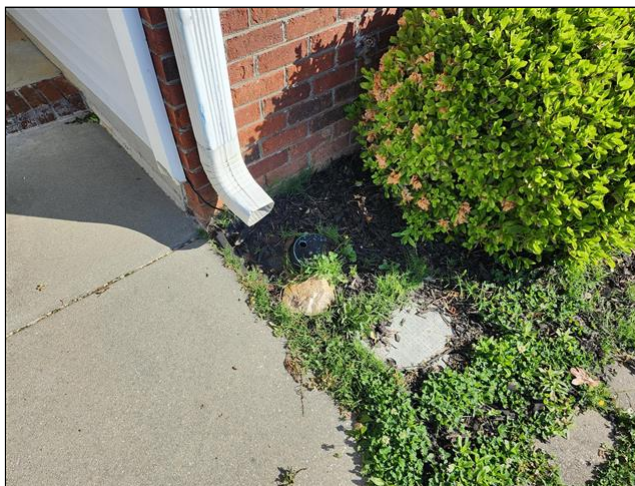
1.3 Item 2 (Picture) Recommend adding a downspout extension

Recommend adding a downspout extension at the front of the house to prevent water from pooling around the foundation (pic2)

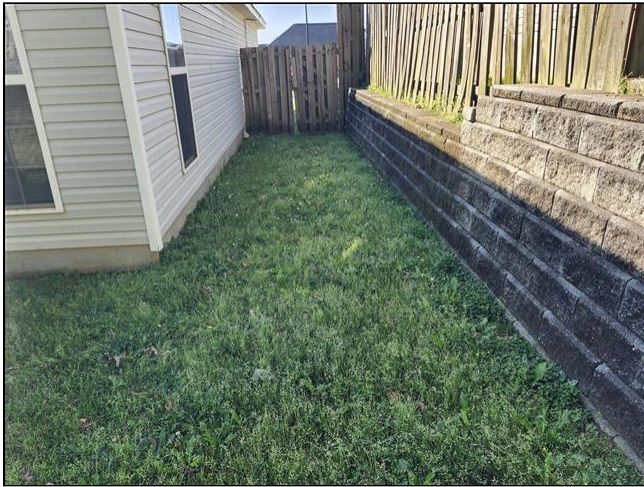
1.3 Item 3 (Picture) Rear of house grading of yard.

The grading of the yard at the left side rear of the house is flat. This may allow pooling of water around the foundation of the home. A gutter system may be needed to prevent water pooling in this area. No pooling of water was observed during this inspection (pic3)

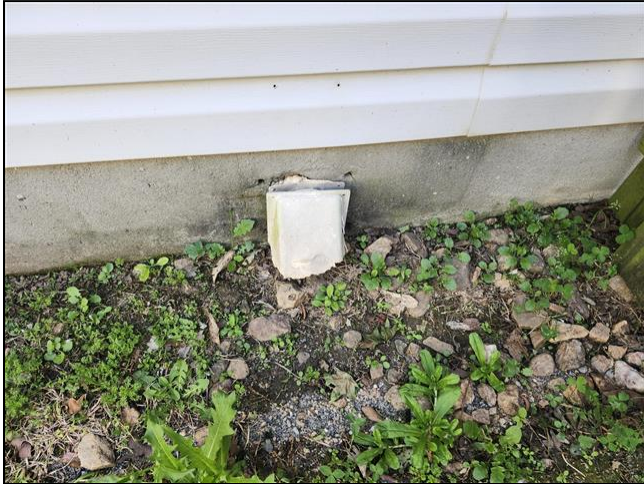
2.0 Item 1 (Picture) Damaged and blocked dryer vent cover

2.0 Dryer vent cover is damaged and faces down into the ground. This can block the venting system. Recommend replacing with a louvered vent cover that faces out and is not obstructed by the ground (pic1).

Dryer vent cover is damaged and faces down into the ground. This can block the venting system. Recommend replacing with a louvered vent cover that faces out and is not obstructed by the ground (pic1).

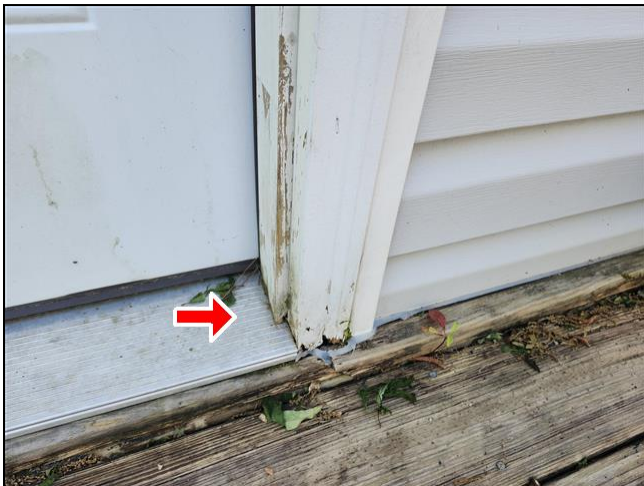
2.1 Item 1 (Picture) Exterior rear door trim moisture damage

2.1 Lower door trim at the rear exterior door has moisture damage. Recommend repair/re-sealing this area to protect from further damage and prevent moisture intrusion.

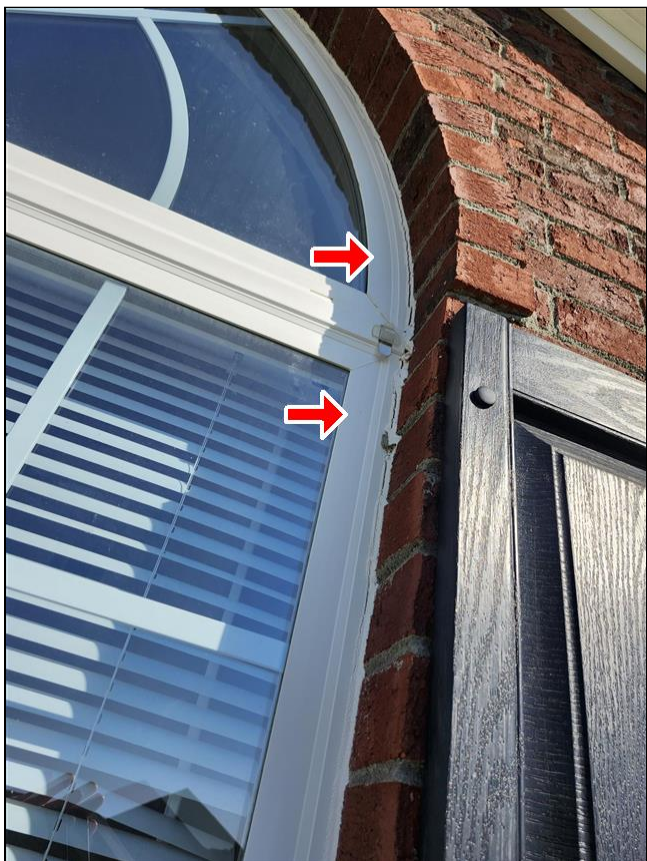
2.2 Item 1 (Picture) Cracked caulking.

2.2 Caulking at the front window is cracked and peeling. Recommend re-caulking around the window.

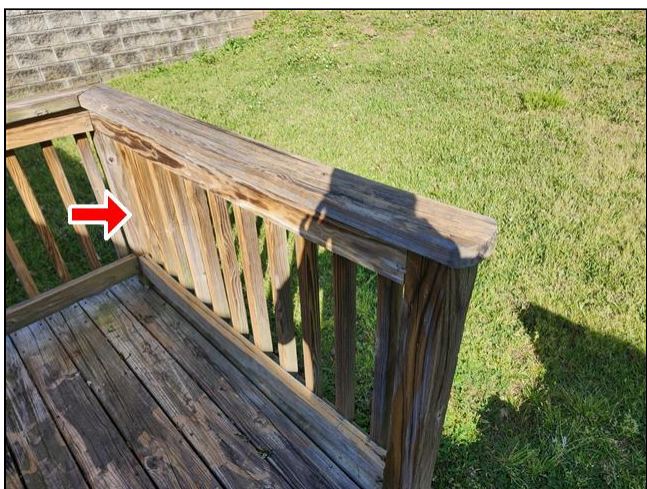
2.3 Item 1 (Picture)

2.3 Deck railing at the rear of the home is loose and needs stabilized. Item 1 (Picture)

The deck needs sealed to prevent further deterioration. Item 1 (Picture)

Deck railing at the rear of the home is loose and needs stabilized. Item 1 (Picture)

The deck needs sealed to prevent further deterioration. Item 1 (Picture)

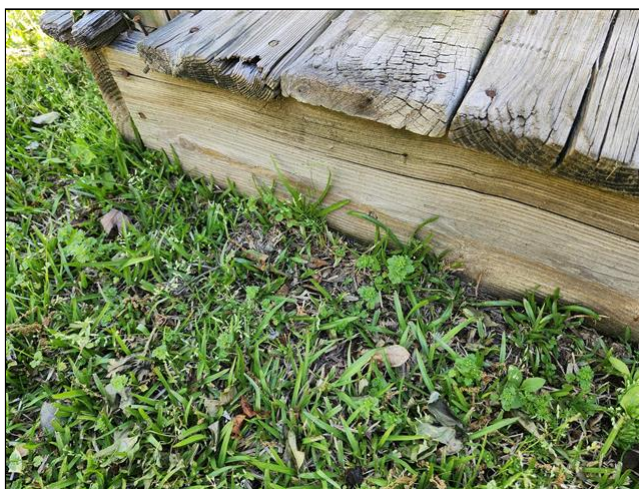
2.3 Item 2 (Picture) Deck in direct contact with soil

The deck is in direct contact with the soil. Inspector could not observe the structure under the deck or verify if the deck rests on concrete pads to separate the wood from the soil. Direct contact with the soil will increase deterioration of the deck over time. Item 2 (Picture)

The deck is in direct contact with the soil. Inspector could not observe the structure under the deck or verify if the deck rests on concrete pads to separate the wood from the soil. Direct contact with the soil will increase deterioration of the deck over time. Item 2 (Picture)

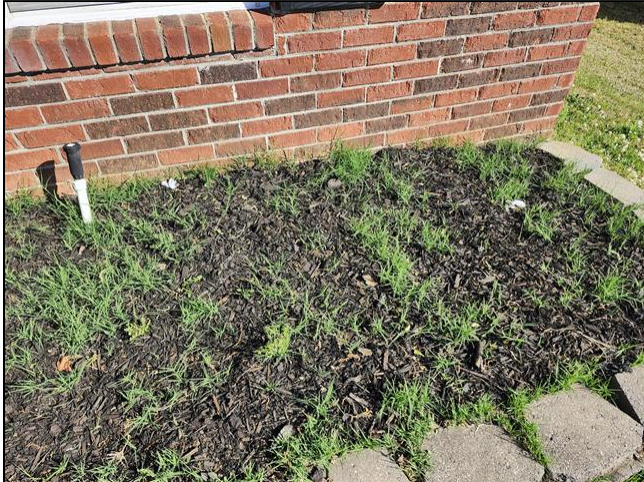
2.4 Item 1 (Picture)

2.4 The dirt in the flower bed at the front of the home is touching the brick veneer. This may allow water or pest intrusion into the home. Recommend lowering the dirt in this area to below the brick veneer.

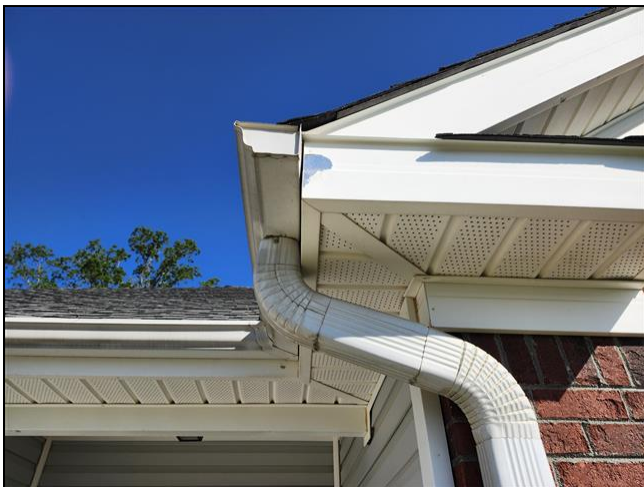
2.5 Item 1 (Picture) Peeled paint at eaves

2.5 Areas of the metal fascia of the eaves around the house have peeling paint. Recommend re-painting these exposed areas to prevent rusting. Item 1 (Picture) Item 2 (Picture)

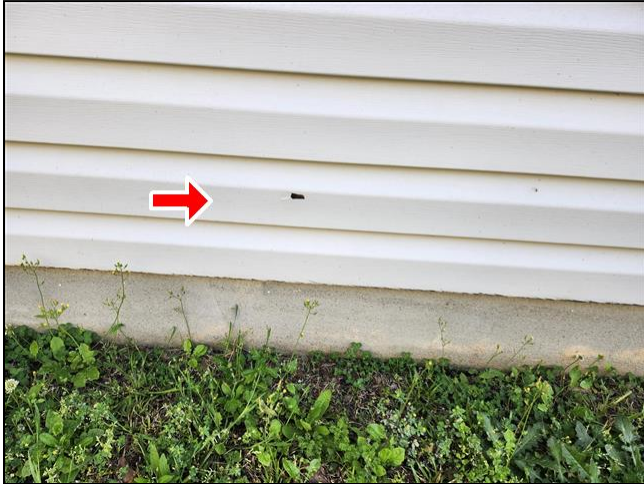
2.6 Item 1 (Picture) Area1 with hole

2.6 Some areas of the vinyl siding on the left side of the home small holes. Recommend filling/patching to prevent moisture intrusion (pics 1-3).

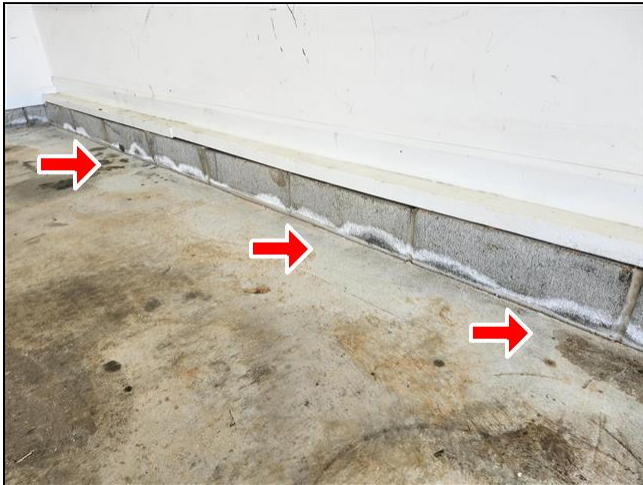
3.1 Item 1 (Picture) Efflorescence on concrete blocks in garage

3.1 Efflorescence was observed on the concrete block in the garage. This is a sign of possible moisture intrusion. No water was observed in the garage during this inspection. Recommend monitoring.

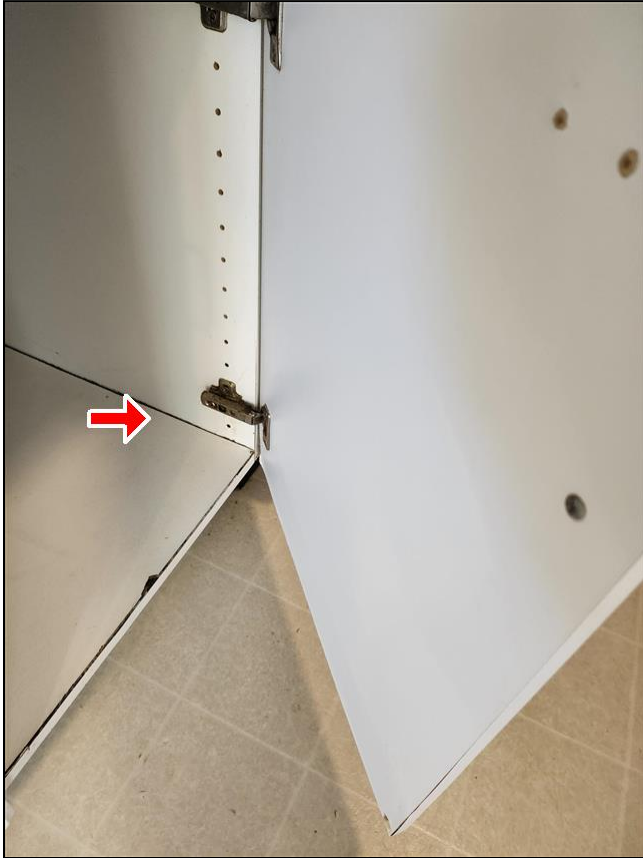
4.4 Item 1 (Picture) Kitchen cabinet door is loose at hinge

4.4 Kitchen cabinet door under the sink (right side) is loose and sagging. Recommend tightening the door hinge to correct. Item 1 (Picture)

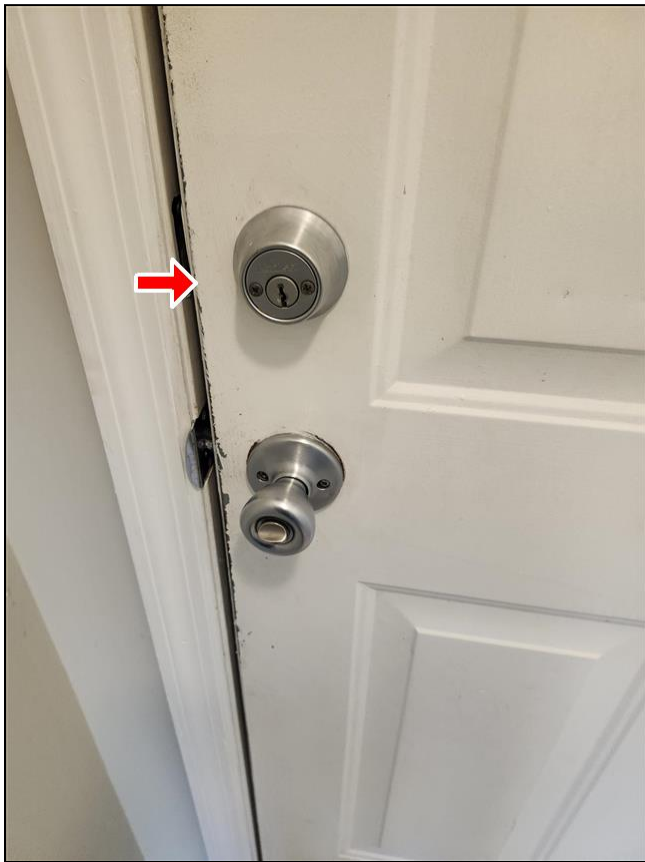
4.5 Item 1 (Picture) Double keyed deadbolts on garage door and rear exterior door.

4.5 The rear exterior door and garage door have double keyed deadbolts. This is a safety issue if the door is locked and the key is not available. Recommend replacing this style with one that has an interior thumbturn and is not keyed on the inside.

The rear exterior door and garage door have double keyed deadbolts. This is a safety issue if the door is locked and the key is not available. Recommend replacing this style with one that has an interior thumbturn and is not keyed on the inside.

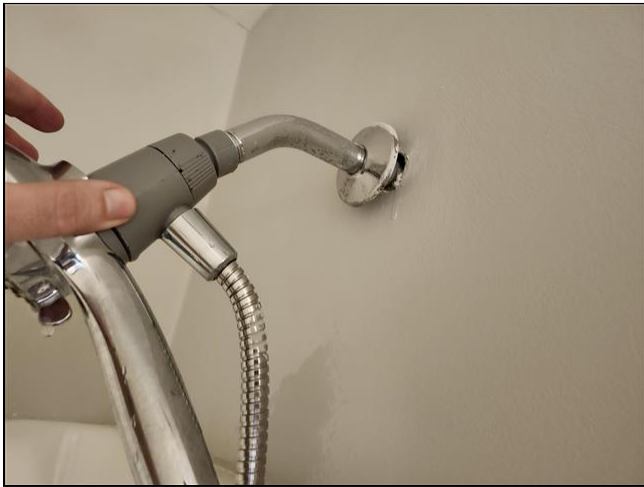
6.1 Item 1 (Picture) Loose shower head

6.1 Hall bathroom shower head is loose in the wall. Recommend further evaluation and repair by a qualified plumbing contractor. Item 1 (Picture)

Hall bathroom shower head is loose in the wall. Recommend further evaluation and repair by a qualified plumbing contractor. Item 1 (Picture)

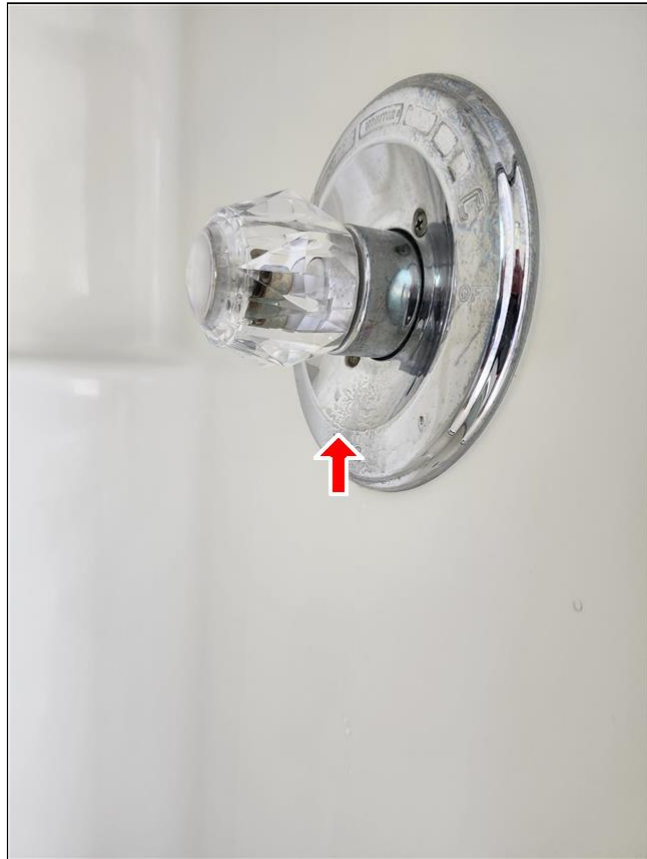
6.1 Item 4 (Picture) Leak at handle

Master Bathroom shower has a slow leak at the handle. Recommend further evaluation/repair by a qualified plumbing contractor. Item 4 (Picture)

Master Bathroom shower has a slow leak at the handle. Recommend further evaluation/repair by a qualified plumbing contractor. Item 4 (Picture)

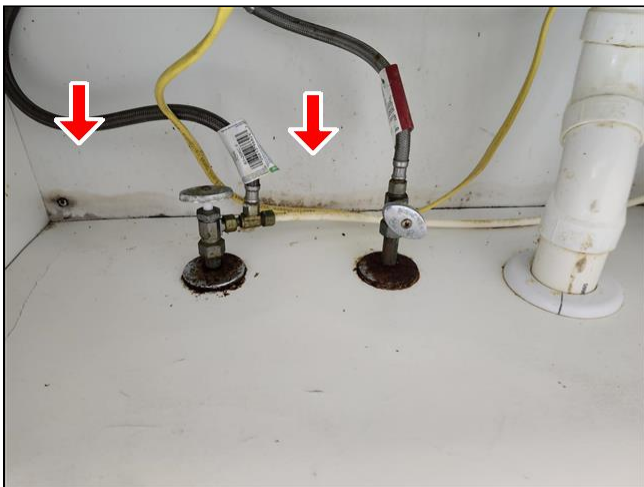
6.1 Item 5 (Picture) Moisture staining in cabinet

Some moisture stains and rust around valve covers were noted under the kitchen sink. The sink was operated and no water leaks were observed during this inspection. This may be from a previous leak. Recommend monitoring.Item 5 (Picture)

Some moisture stains and rust around valve covers were noted under the kitchen sink. The sink was operated and no water leaks were observed during this inspection. This may be from a previous leak. Recommend monitoring. Item 5 (Picture)

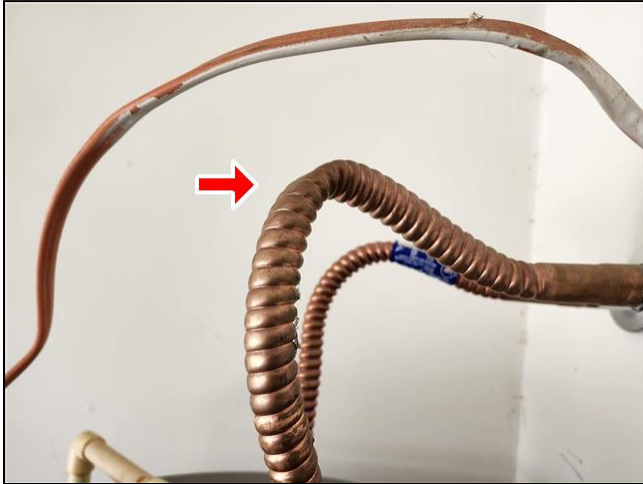
6.2 Item 1 (Picture) Pinched water line.

6.2 Copper flex water line attached to the top of the water heater in the garage is bent and pinched This may impede water flow. Recommend further evaluation by a qualified plumbing contractor. Item 1 (Picture)

Copper flex water line attached to the top of the water heater in the garage is bent and pinched This may impede water flow. Recommend further evaluation by a qualified plumbing contractor. Item 1 (Picture)

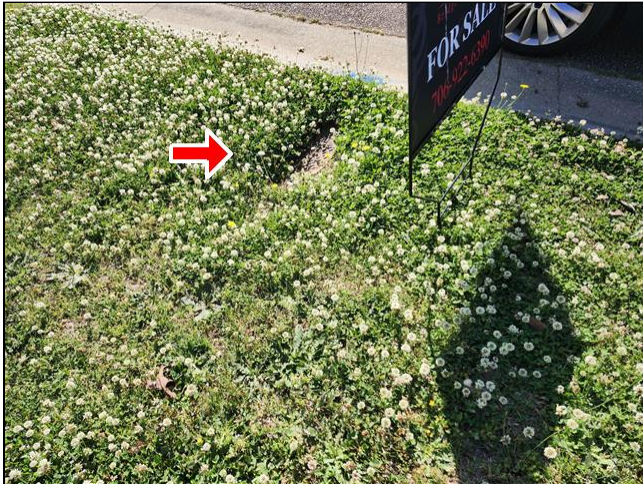
6.3 Item 1 (Picture) Main water shutoff

6.3 Main water shutoff is located at the street (right side)

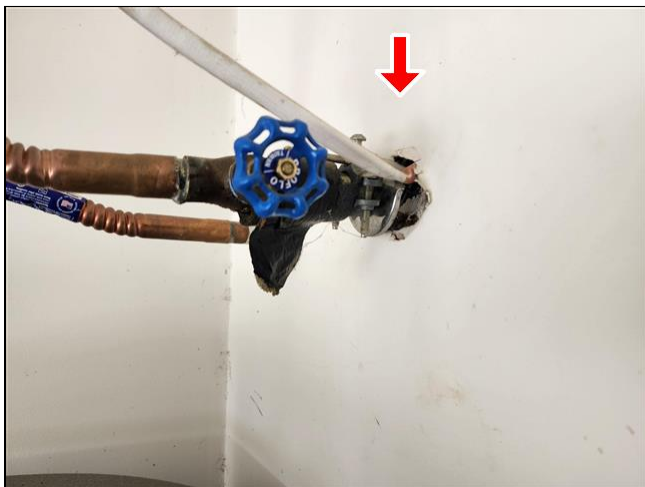
7.2 Item 1 (Picture) Electrical wire at water heater supply line.

7.2 The water heater supply line extending through the wall in the garage has an electrical wire running along next to some bent and sharp metal flange. This may rub and the wire and cut into the electrical wire over time. Recommend further evaluation by a qualified electrician.

The water heater supply line extending through the wall in the garage has an electrical wire running along next to some bent and sharp metal flange. This may rub and the wire and cut into the electrical wire over time. Recommend further evaluation by a qualified electrician.

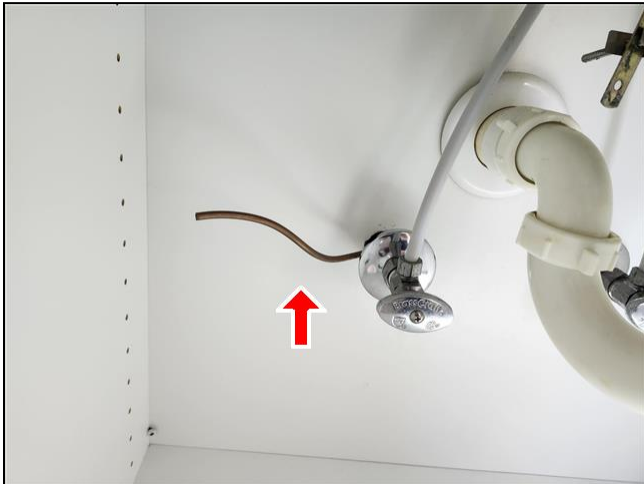
7.3 Item 1 (Picture) Ground wire under master bathroom sink (left side).

7.3 A ground wire was observed extending from the sink valve (left sink) in the master bathroom. Recommend further evaluation by a qualified electrical contractor as to the purpose of this wire.

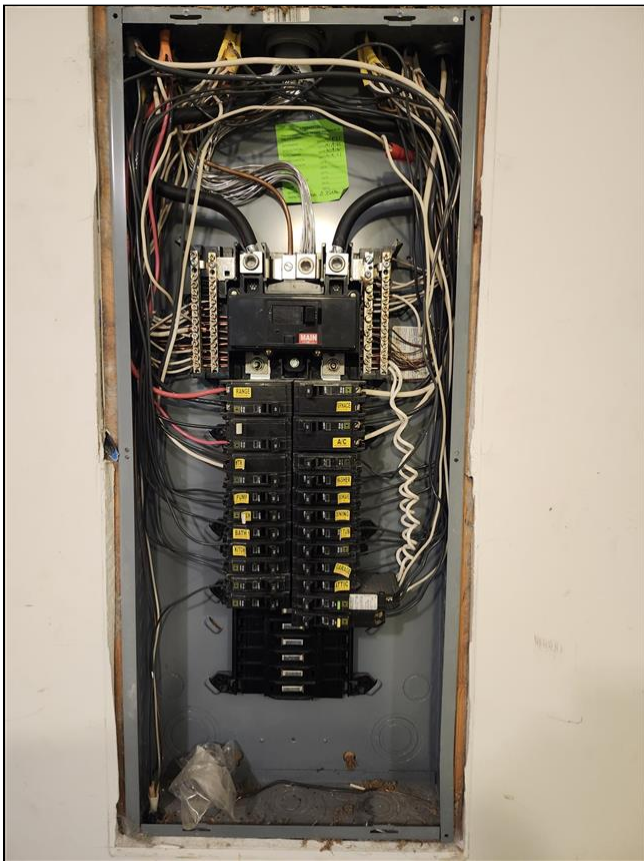
7.6 Item 1 (Picture) Electrical breaker panel in garage

7.6 The electrical breaker panel is located in the garage.

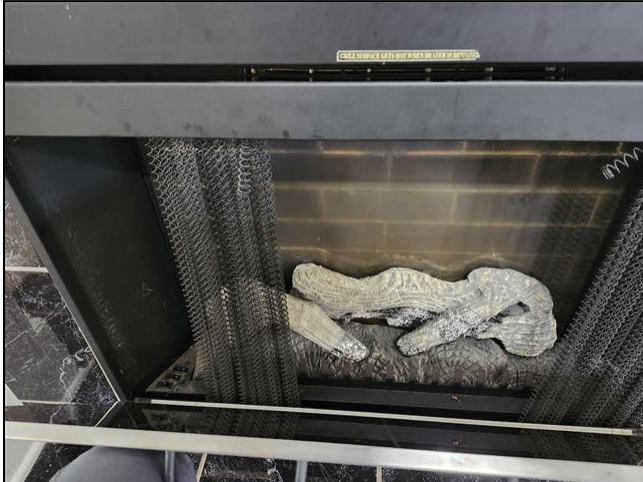
8.7 Item 1 (Picture)

8.7 This home has an electric fireplace. This was not inspected. Recommend asking the seller for instruction on the operation of this device.

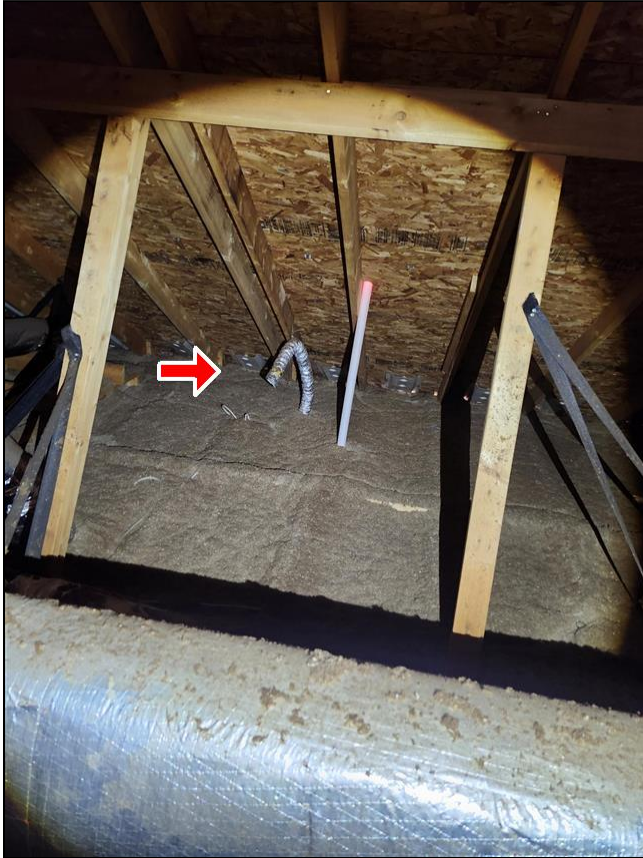
9.2 Item 1 (Picture) Bathroom vent terminates in the attic.

9.2 Hall bathroom vent line terminates in the attic space. Recommend extending this vent line to the exterior of the home to prevent moisture in the attic space.

Hall bathroom vent line terminates in the attic space. Recommend extending this vent line to the exterior of the home to prevent moisture in the attic space.

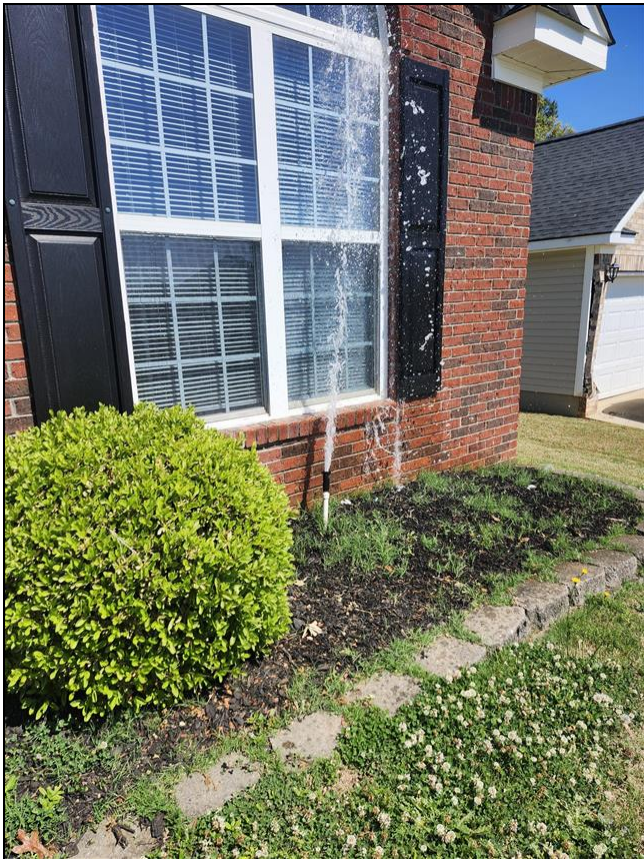
11.1 Item 1 (Picture) Sprinkler head at front of home is broken.

11.1 The sprinkler head at the front of the home is broken and needs replaced.

The sprinkler head at the front of the home is broken and needs replaced.
